COMMUNITY POOL

The community swimming pool, originally opened in 1964, underwent a renovation in 2006. Despite this, it faces multiple structural and functional challenges that compromise its usability and safety. The main swimming pool, measuring 11,000 square feet and holding 325,000 gallons of water, experiences significant water loss of over two inches per day. This is coupled with rust and corrosion on its copper metal walls, leading to recurring maintenance issues. Staff attempt patches annually, but the deterioration persists, and due to the state of the structure, reuse of the pool is not recommended.

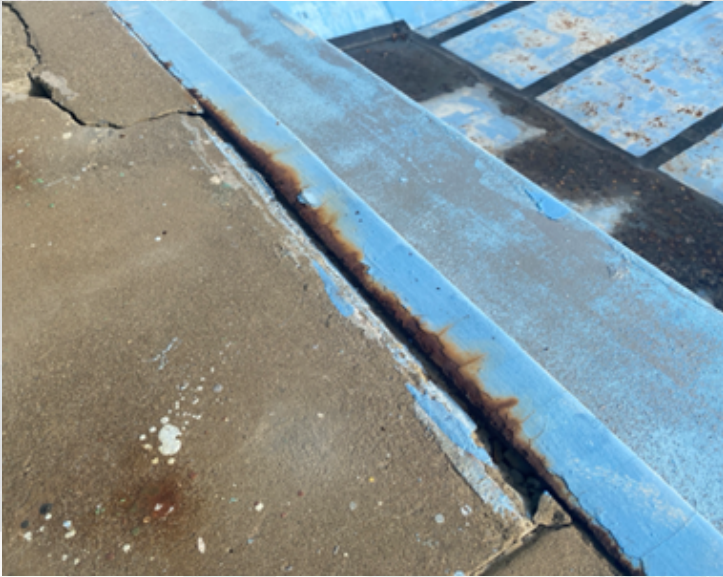
Top left: Pool Separation from Deck

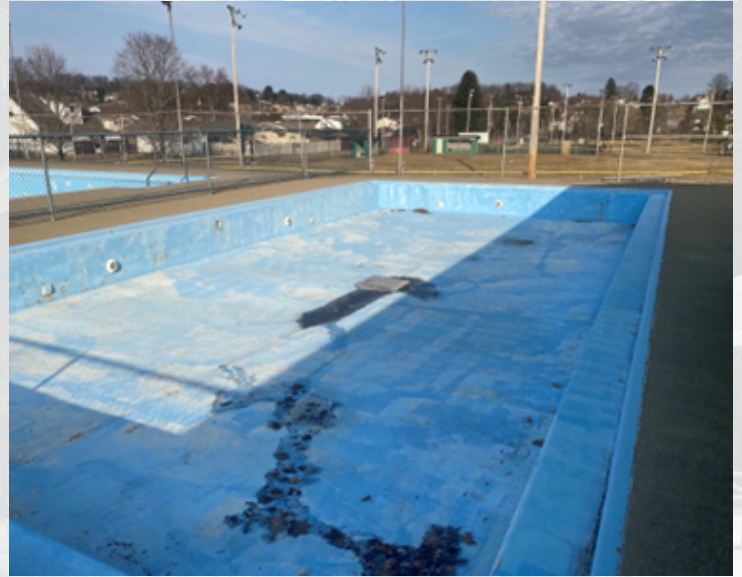
Safety and compliance issues are also a concern. The location of the pool backwash does not meet current codes and standards. Additionally, pool chemicals are stored in the mechanical room, and the high-rate sand filters are exposed to the elements year-round due to the storage building not being fully enclosed. The children's pool shares the same recirculation system as the main pool which is not designed to current codes.

Top right: Children's Pool

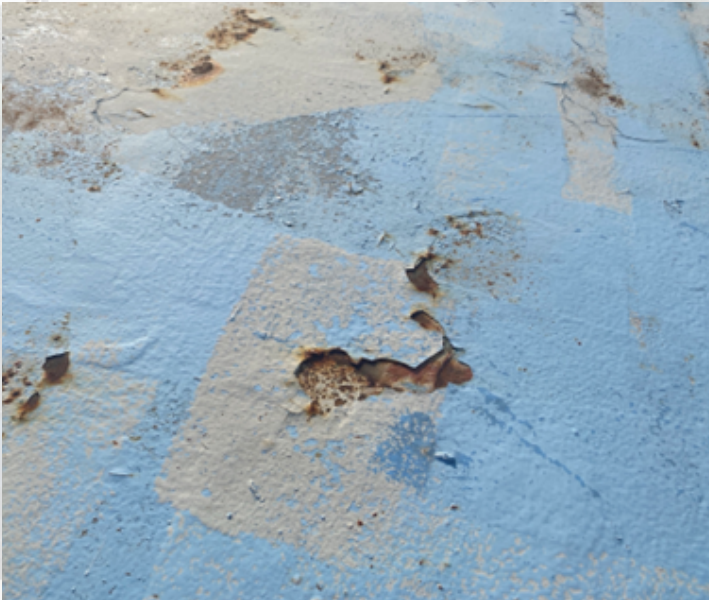
Top left: Pool Rust and Corrosion

When looking at options for repair, the use of a new wall system called Myrtha RenovAction is a typical solution for aging pools. However, this system is not able to be used to reinforce the existing walls as the existing steel will continue to degrade if it is not stabilized before the panel system is installed. Given the condition of the walls, this is not a viable solution. A temporary solution could be to install two layers of a pool membrane within the existing pool to block the rust from bleeding through. This might give the swimming pool up to 10 years of life at a cost of \$2.5M to \$3M. This cost addresses the pool shell, but does not include the cost of new mechanical equipment and a new pool deck.

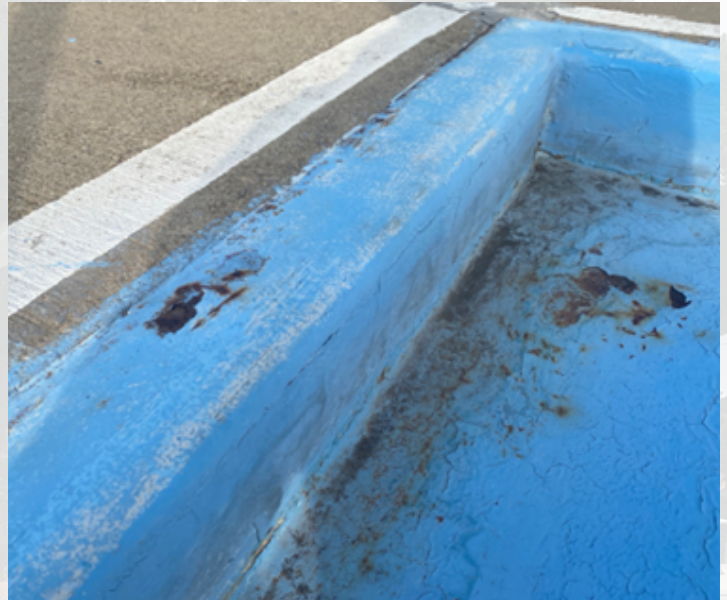
The pool's perimeter overflow gutters fail to function effectively for surface skimming, and its trough-style gutter system further limits skimming capability. Over time, the pool has shifted, causing uneven water levels, which hampers proper water recirculation. Although renovations in 2006 addressed some components of the recirculation system, the pool heater struggles to maintain temperatures above 78 degrees.

Top right: Pool Gutter System

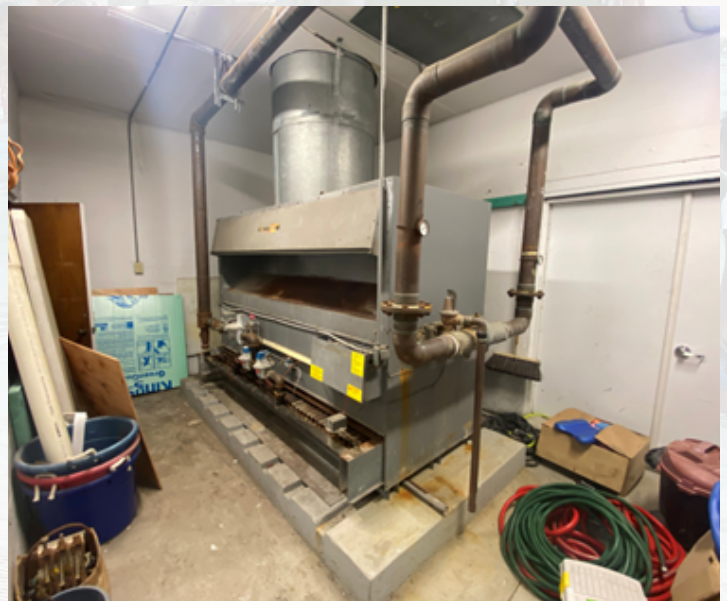
Bottom right: Pool Heater

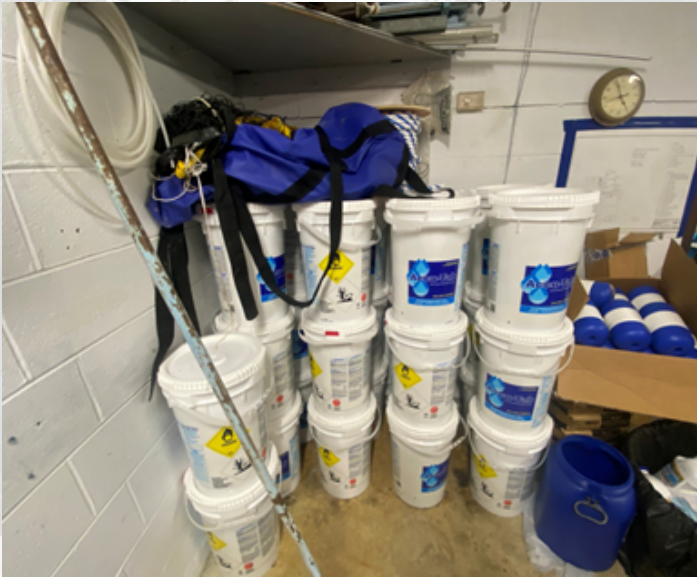
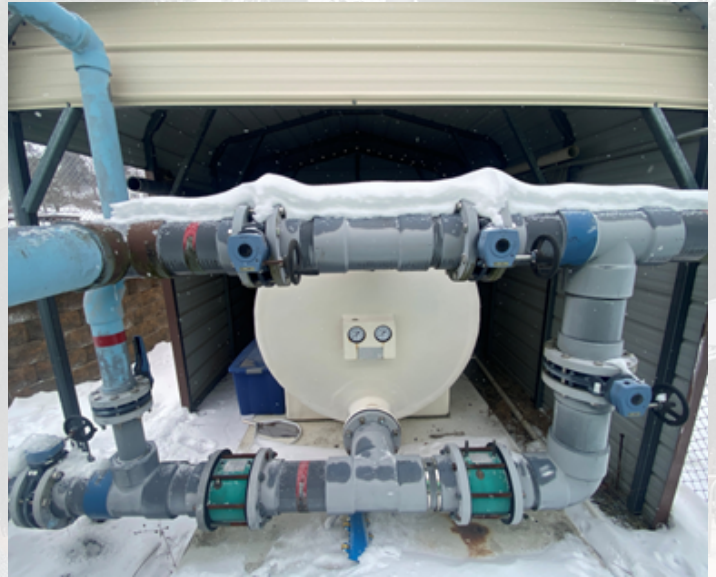
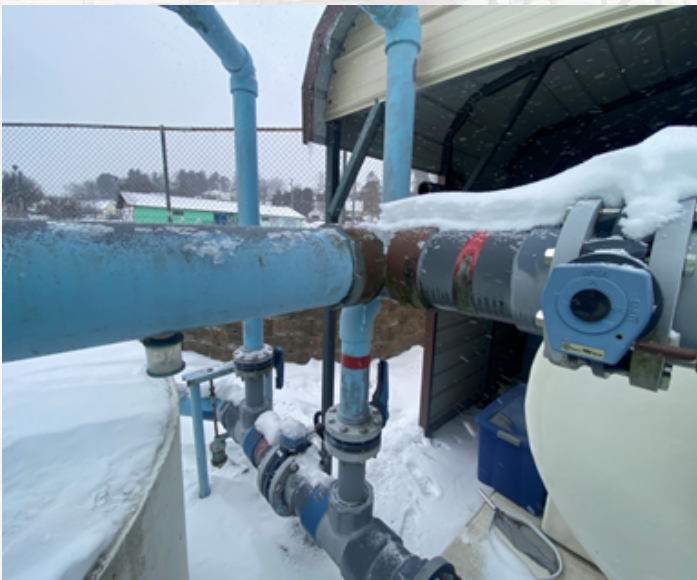
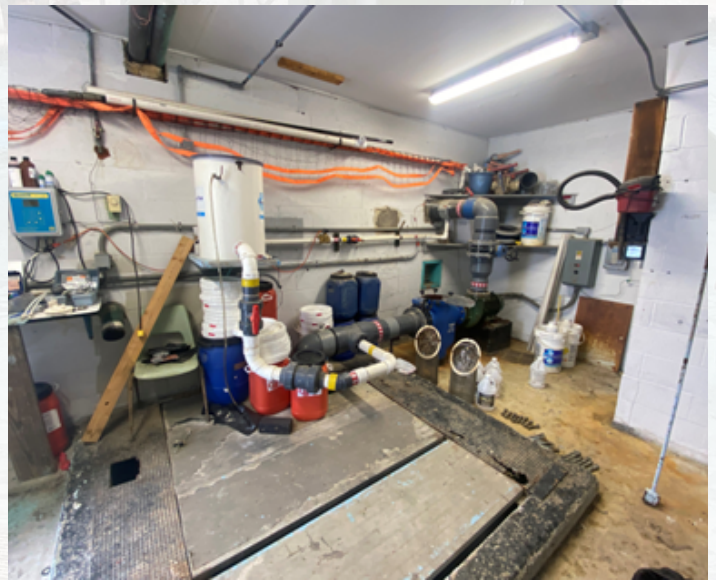
Top left: Pool Chemical Storage
Top right: Recirculation Piping and Filtration
Bottom left: Recirculation Piping
Bottom right: Pool Mechanical Room

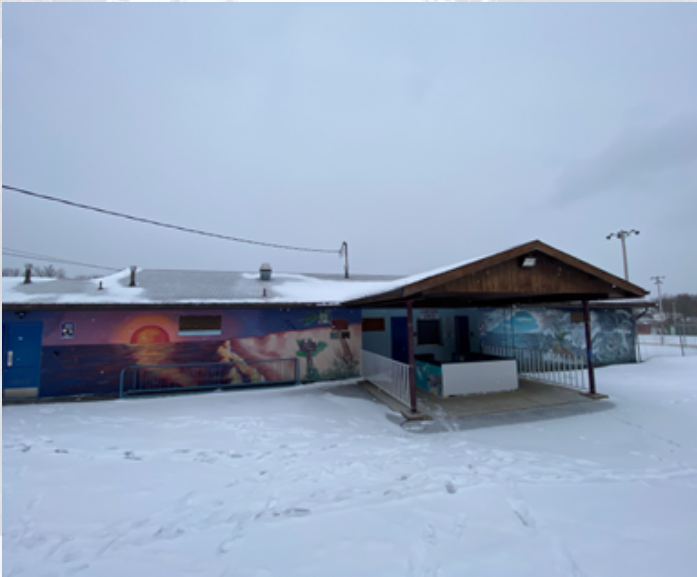
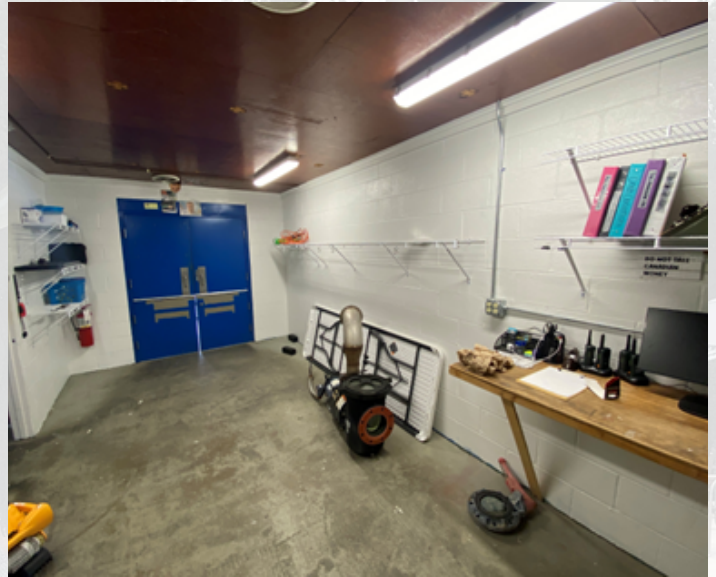
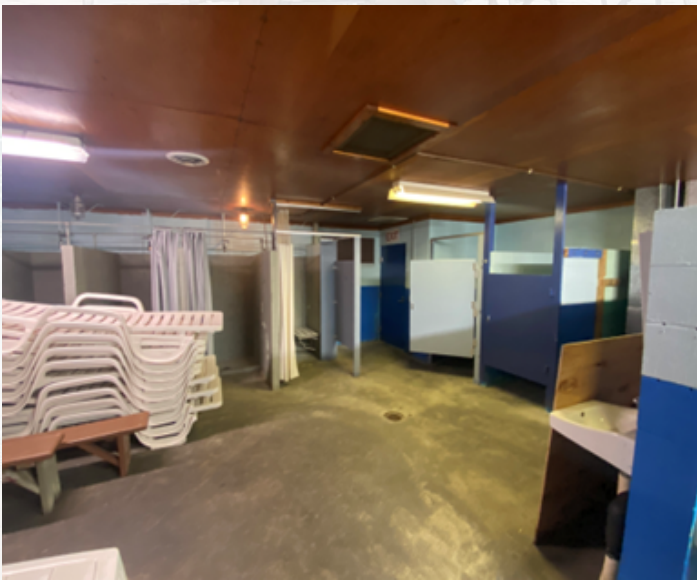
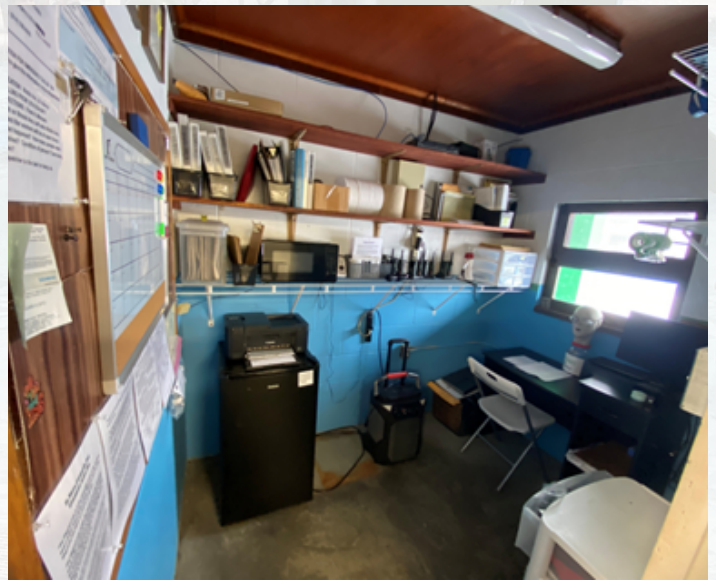
The supporting infrastructure is equally in need of attention. The mechanical system building requires a new roof, while the entry building and locker rooms are in dire need of remodeling. The lifeguard area lacks sufficient space for all staff members. And, on busy summer days, there is not ample parking for all users of the swimming pool and the park.

Top left: Entry Building
Top right: Entry Corridor
Bottom left: Locker Room
Bottom right: Pool Office

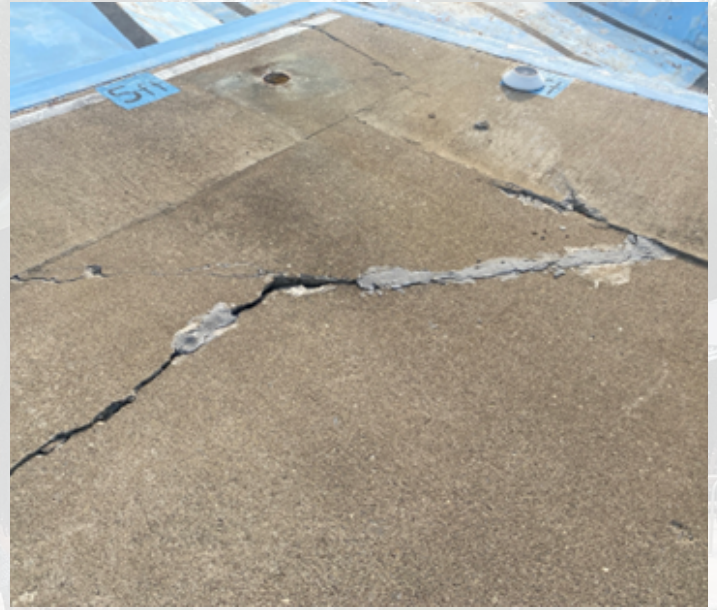
Right: Pool Deck Cracking
