Safety Inspection Report

St. Marys Community Pool

February 3, 2026

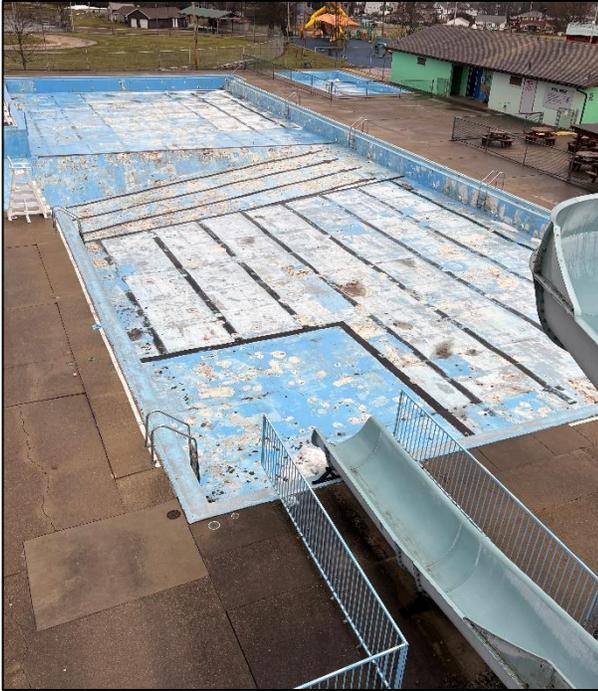
Photo 1 – Pool from slide tower, Looking East

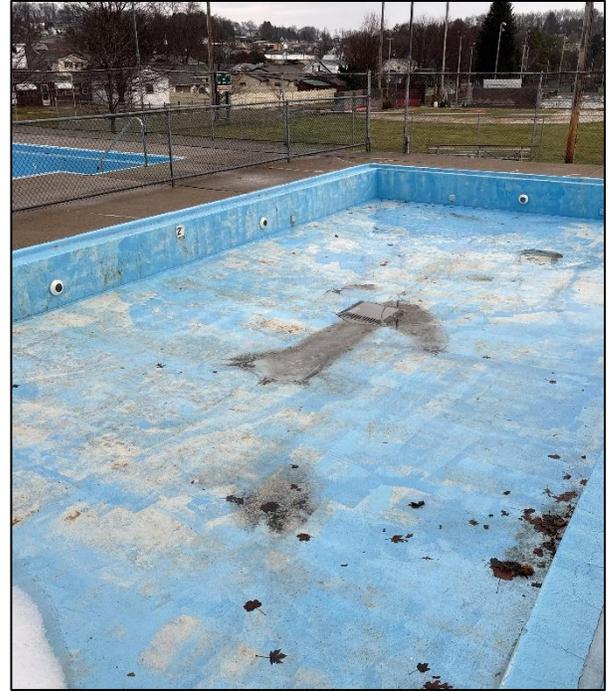
Photo 2 – Children's pool, Looking East

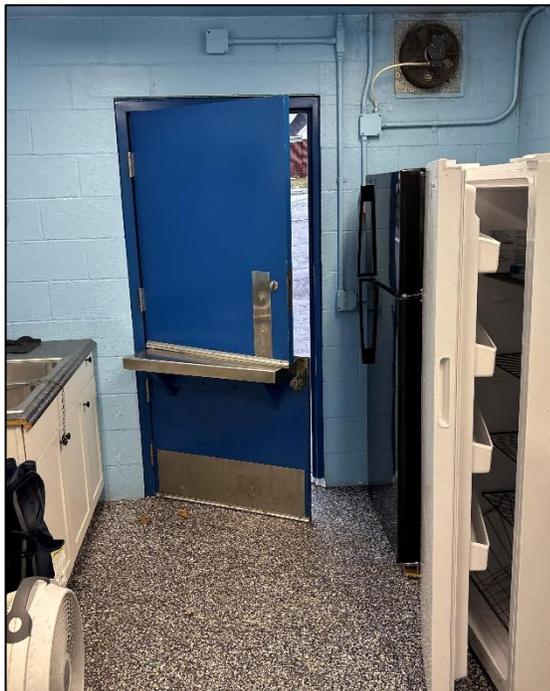
Photo 3 – Concessions, Looking South

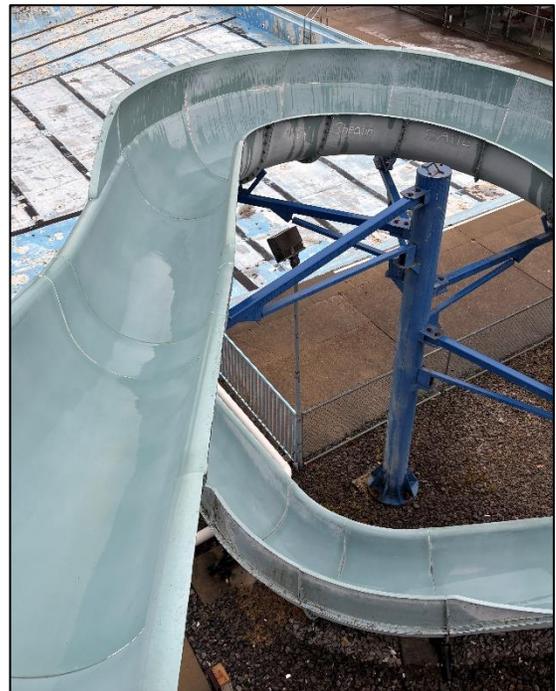
Photo 4 – Slide, Looking Southeast

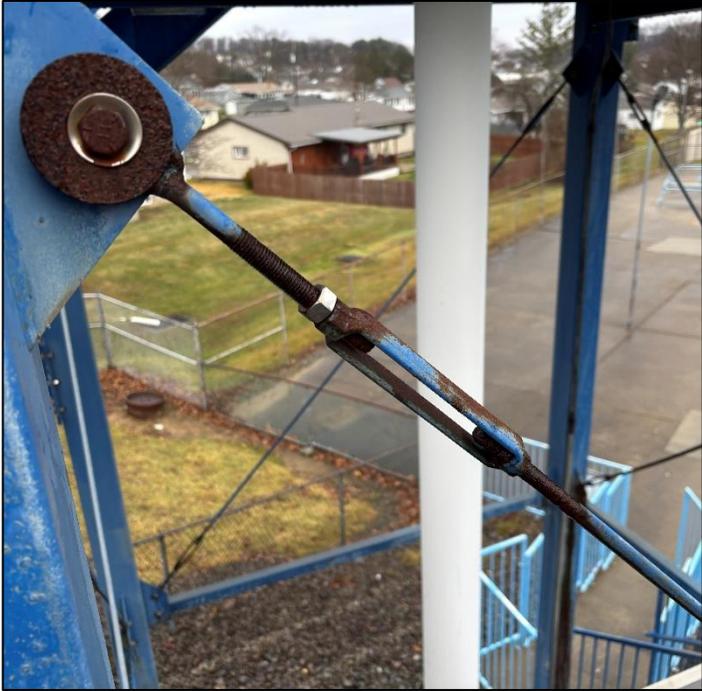
Photo 5 – Rusting slide tower hardware, Looking East

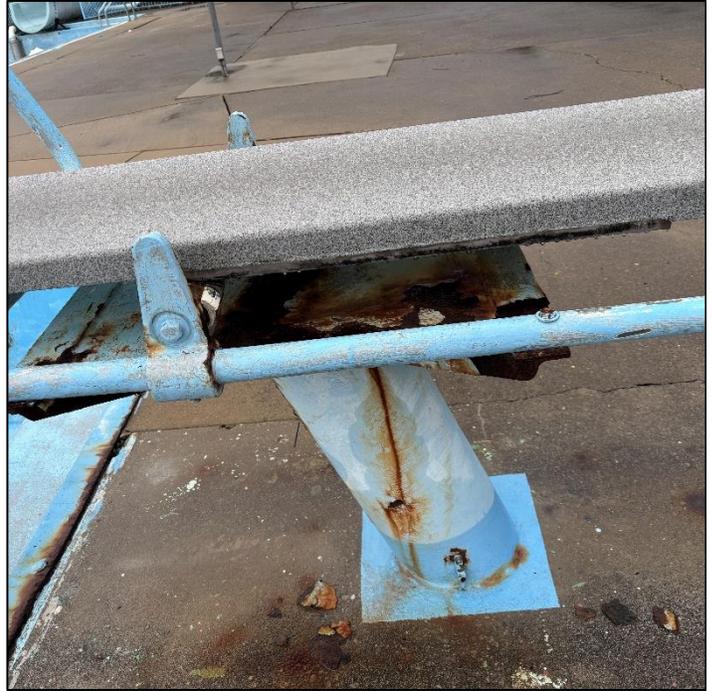
Photo 6 – Rusting diving board stand, Looking West

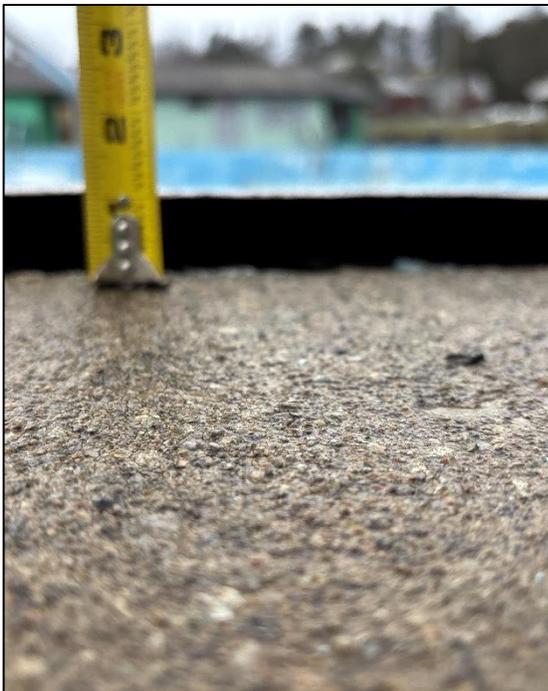
The pool liner has separated from the concrete deck in several locations. This is particularly noticeable near the diving boards where 1-inch vertical and horizontal gaps were observed.

The copper liner is shifting away from the concrete deck creating a trip hazard and allowing water to infiltrate behind and below the liner. The undulating bottom of the pool and the unsupported feel underfoot implies a compromise in the base material caused by water infiltration through or around the liner.

Photo 7 – Pool basin separated from deck in diving area, Looking South

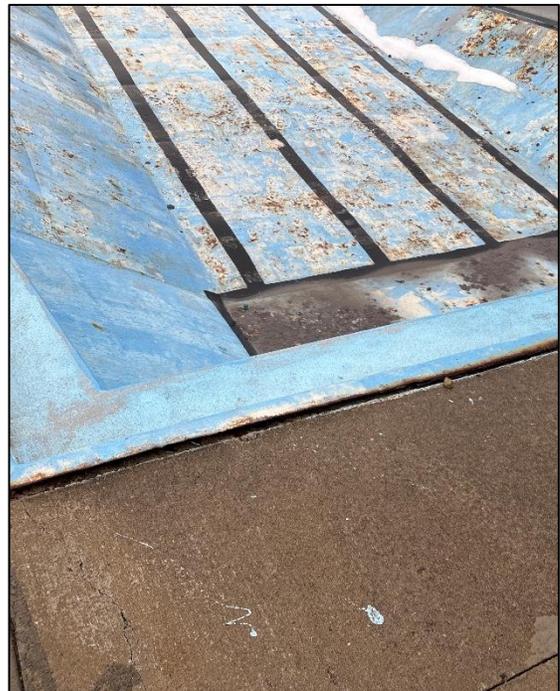
Photo 8 – Pool basin separating from deck, Looking South

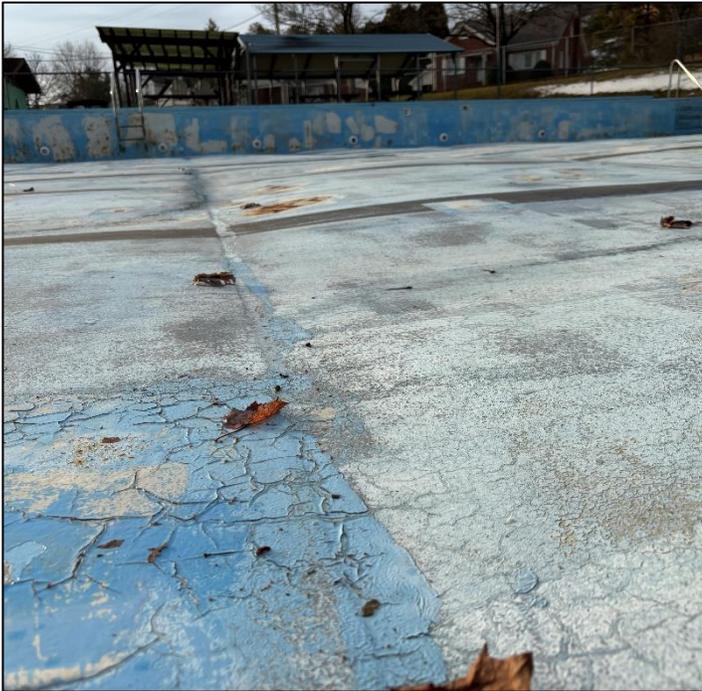
The main swimming pool, measuring 11,000 square feet and a capacity of approximately 325,000 gallons of water. Rust and corrosion were observed on its copper metal walls. Several patches in the liner material were observed. The bottom of the pool is not flat and undulates in nature. The pool basin bottom had substantial give when walked upon in several locations suggesting a compromise in base material under the bottom.

Photo 9 – Undulating pool bottom with recent patch, Looking South

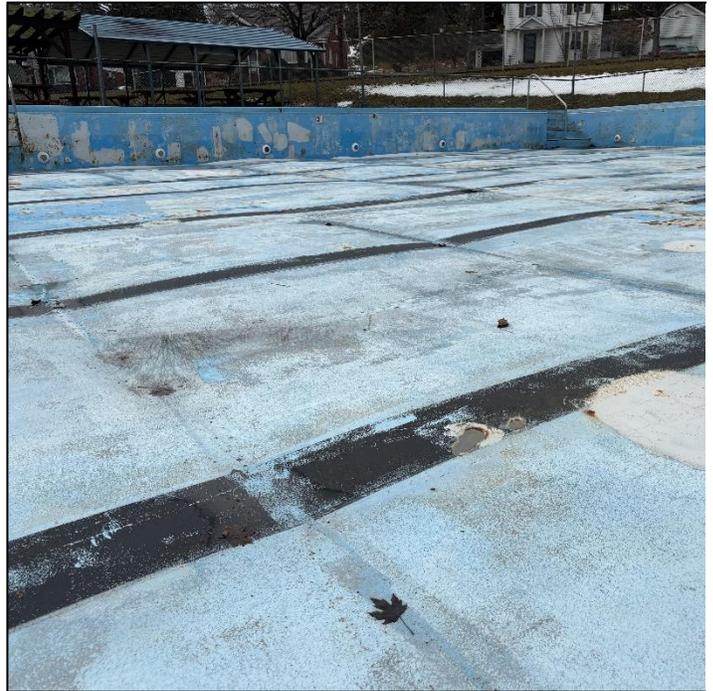
Photo 10 – Undulating pool bottom with various patches, Looking Southwest

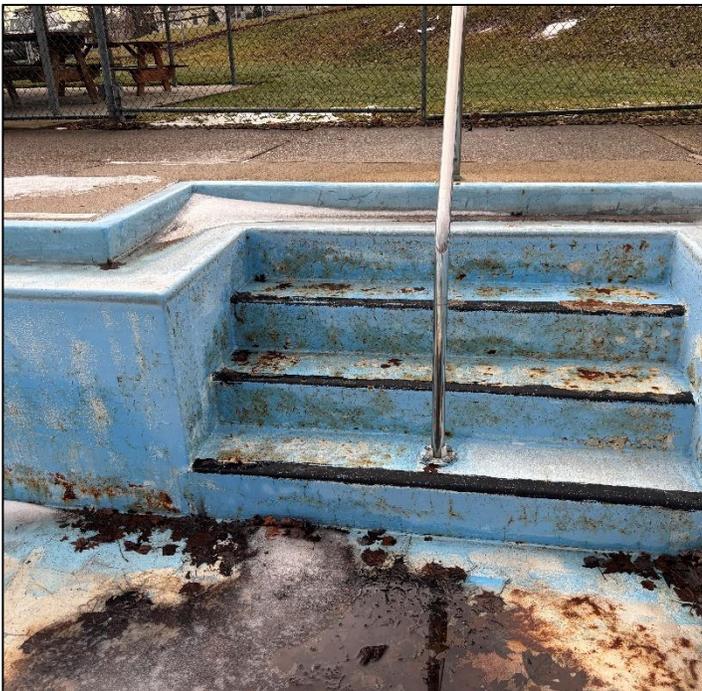
Accessible routes were observed into and throughout the facility. A pool lift was observed stored in the changing room and its deck anchor point found near the pavilions. While a transfer wall was not found, stairs and a handrail were in the southwest corner of the larger pool.

Photo 11 – Pool entry stairs with handrail, Looking South

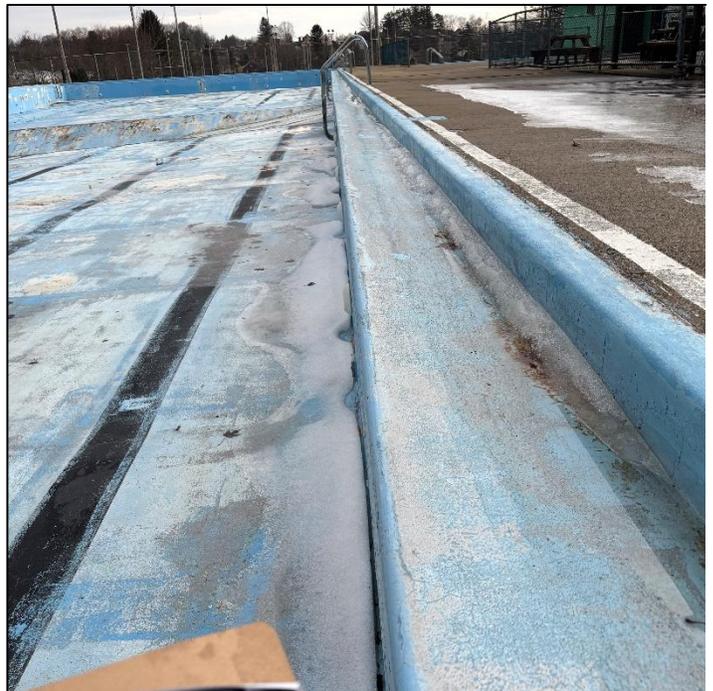
The trough-style gutter system limits skimming capability. Ice was observed in several areas of the gutter indicating an inadequate slope and/or drain holes within the trough to relieve the stagnant water. The gutter system is made of a similar copper metal material as the basin, and the same rust and corrosion conditions were observed throughout the gutter system.

Photo 12 – Pool gutter system with ice accumulation, Looking East

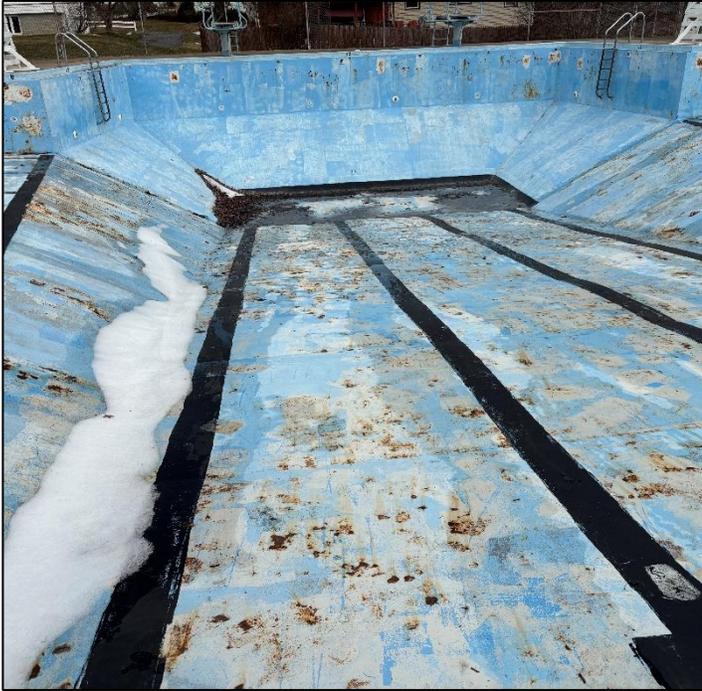
The copper metal walls and pool bottom show substantial rust and corrosion with several patches identified. In addition to the obvious hazardous surface touch points for bathers, water loss through the basin is suspected. A temporary solution option is to install a pool membrane interior to the existing copper liner to block rust.

Photo 13 – Rusted pool bottom in diving area, Looking North

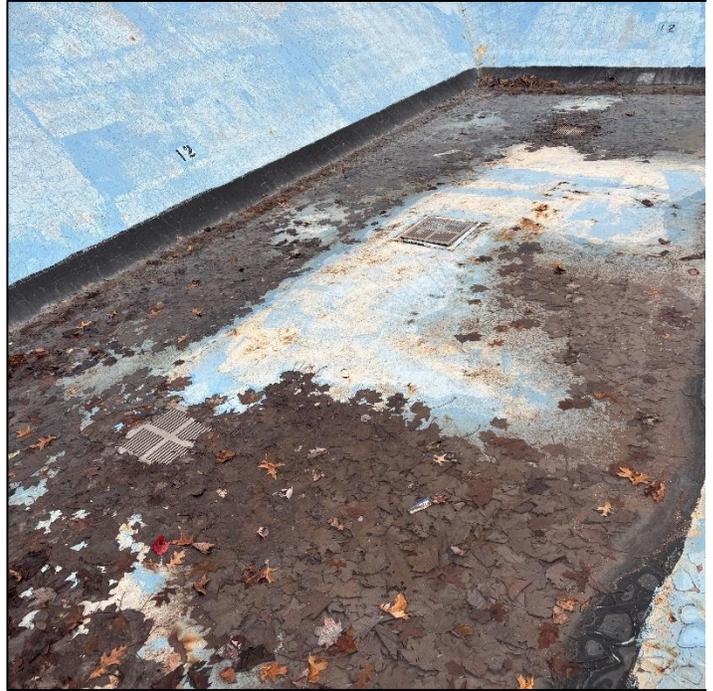
There are three main drains in the diving portion of the larger pool. The drains are higher than the surrounding areas in the diving area as evidenced by the standing water surrounding the drains. The drain spacing is compliant with the Public Bathing Law to prevent entrapment and entanglement. The drain covers were found intact but not secured and VGB labeling was not found on these drain covers.

Photo 14 – Raised drains in diving area, Looking Northeast

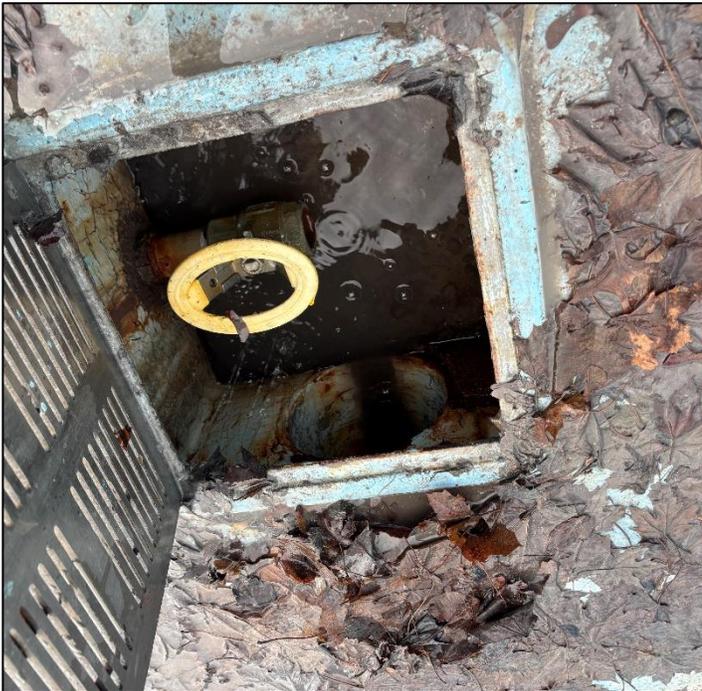
Photo 15 – Unsecure and non-VGB compliant drain cover in diving area.

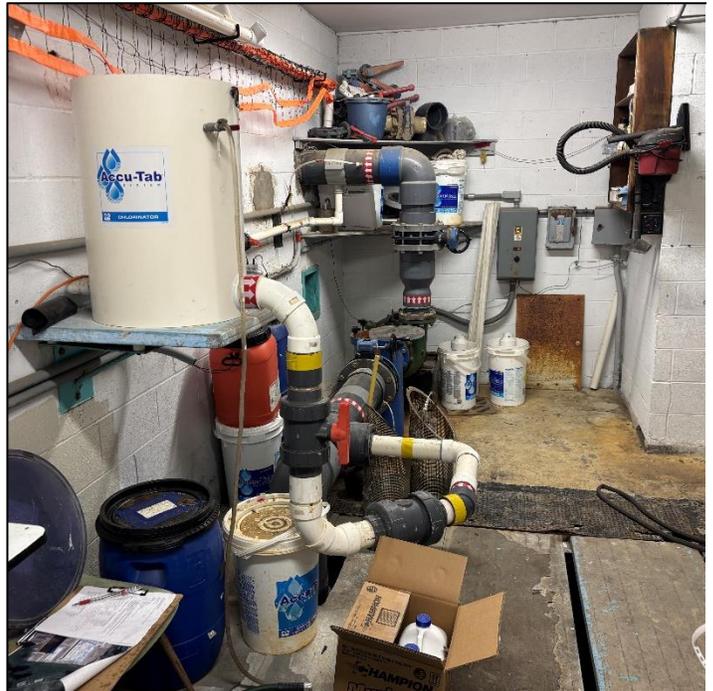
Photo 16 – Pool pump, motor, chlorinator and strainer, Looking North

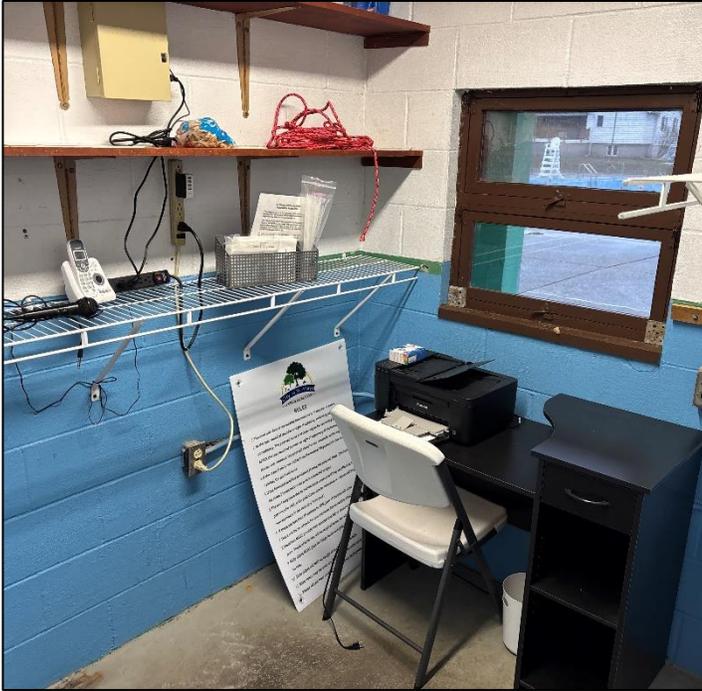
The pool office is undersized for the lifeguard needs of the pool.

Photo 17 – Pool office, Looking North

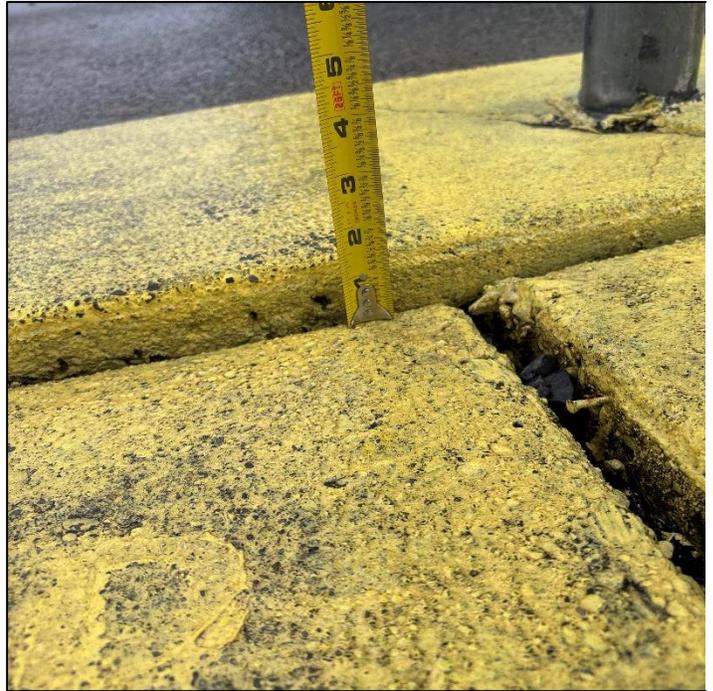
The concrete pool deck is continuous and appears to promote positive drainage away from the pool. Icy ponded areas were observed between the pavilion and the large pool and on the pool side of the entrance building, both indicated poor drainage slopes. The concrete surface was found to be slip-resistant but numerous trip hazards were identified where the concrete has spalled, cracked, heaved, or otherwise broken leaving height differences as much as two inches. Expansion joints have mostly been compromised.

Photo 18 – Uneven concrete near pavilions

The concrete deck is in disrepair throughout the facility. Several patching and crack sealing areas were identified, but the concrete is heaving in some areas and showing signs of differential settling in other areas. The deck requires complete replacement to correct differential settlement/heaving and mitigate associated tripping hazards.

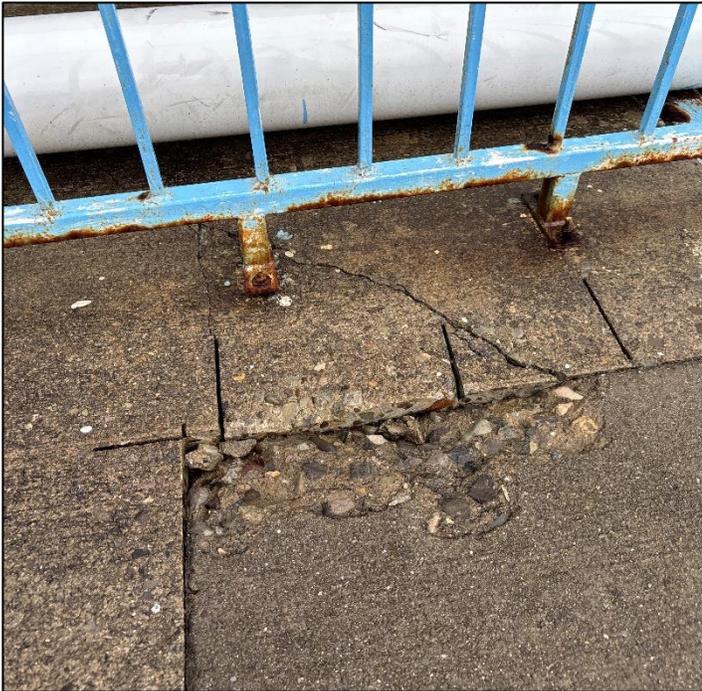
Photo 19 – Spalled and uneven concrete near water slide, Looking North

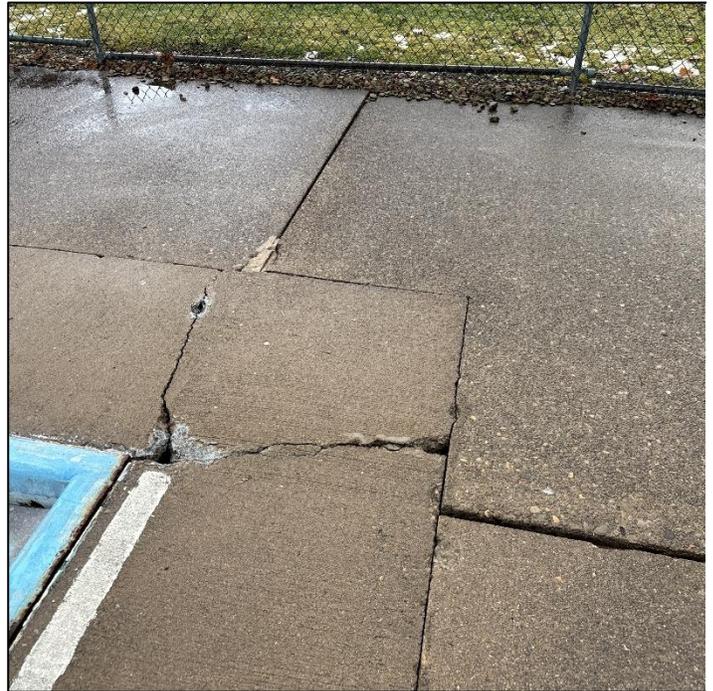
Photo 20 – Broken concrete deck near southwest stairs, Looking South

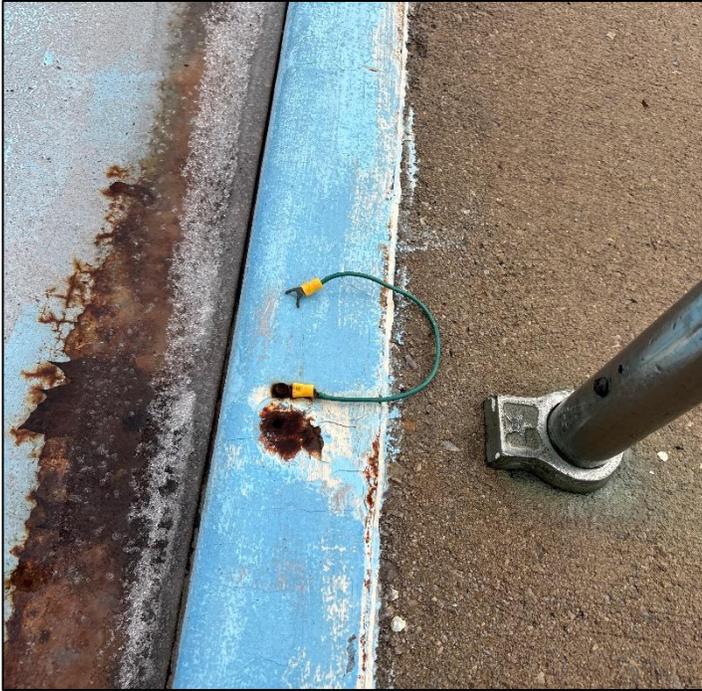
Several grounding straps on pool ladders and hose bibs were found to be compromised throughout the facility. Exterior and interior lights and conduits were found to be in acceptable condition.

Photo 21 – Typical broken electrical grounding

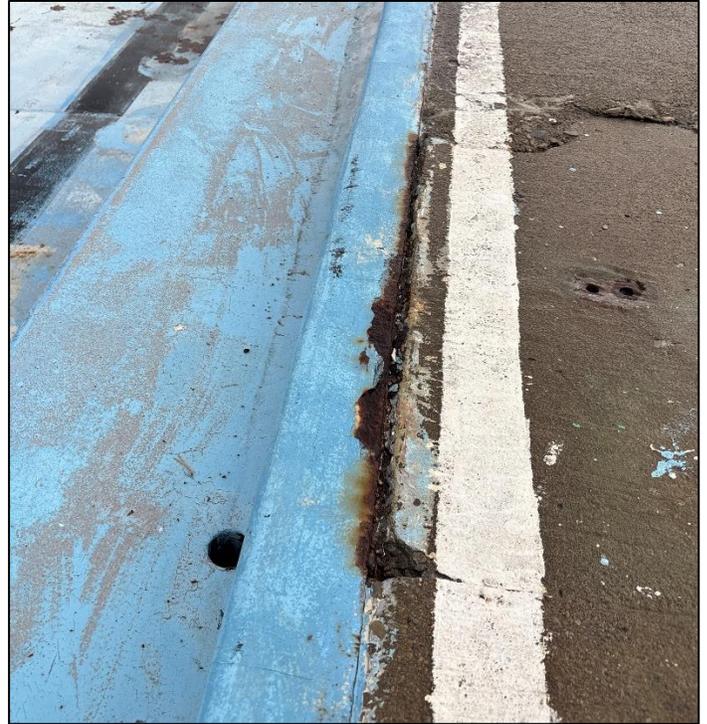
**Photo 22 – Rusted pool gutter edge(center).
Broken and uneven concrete (right).**

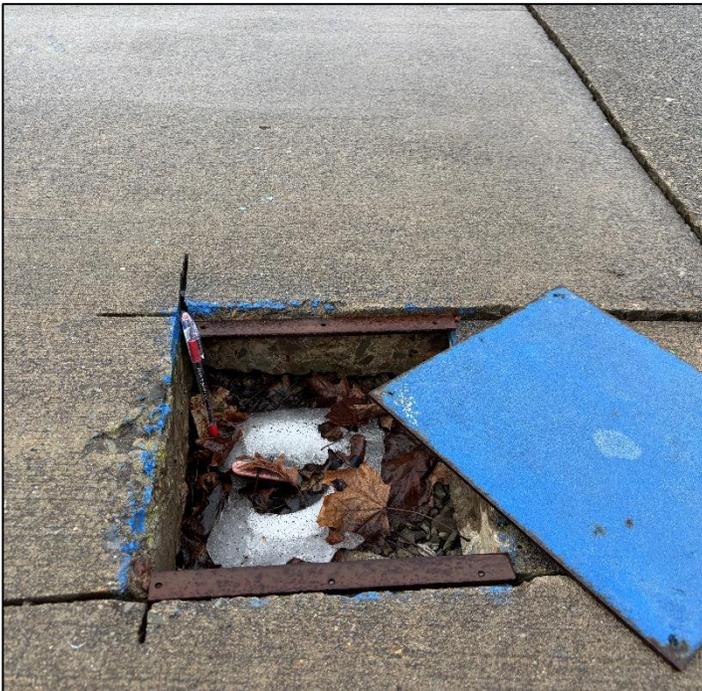
**Photo 23 – Unsecured rusted access cover (center).
Uneven concrete (right)**

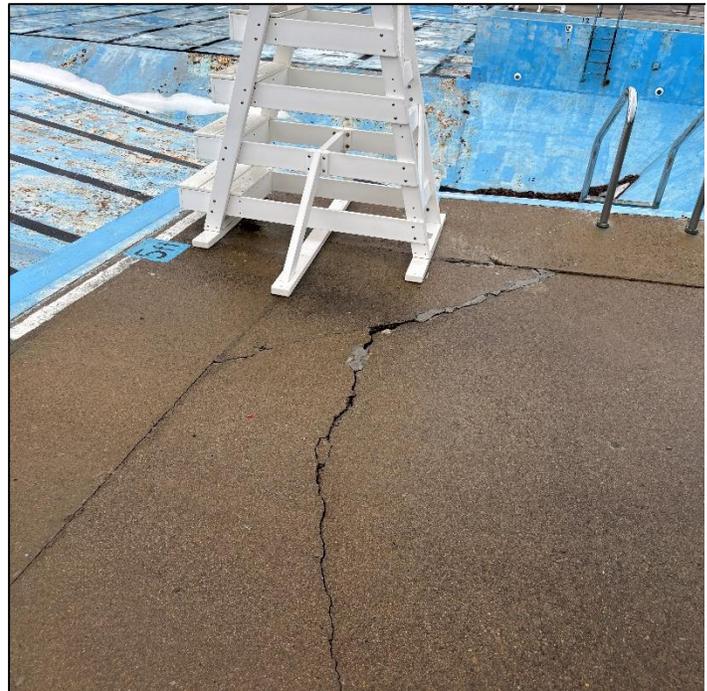
**Photo 24 – Broken and uneven concrete deck with
failed patching near diving area, Looking West**
